UNDERWATER BRIDGE INSPECTION REPORT

STRUCTURE NO. 55520
CSAH NO. 12
OVER THE
ZUMBRO RIVER
DISTRICT 6 - OLMSTEAD COUNTY

PREPARED FOR THE
MINNESOTA DEPARTMENT OF TRANSPORTATION
BY
COLLINS ENGINEERS, INC.
JOB NO. 5221 (CEI 151)

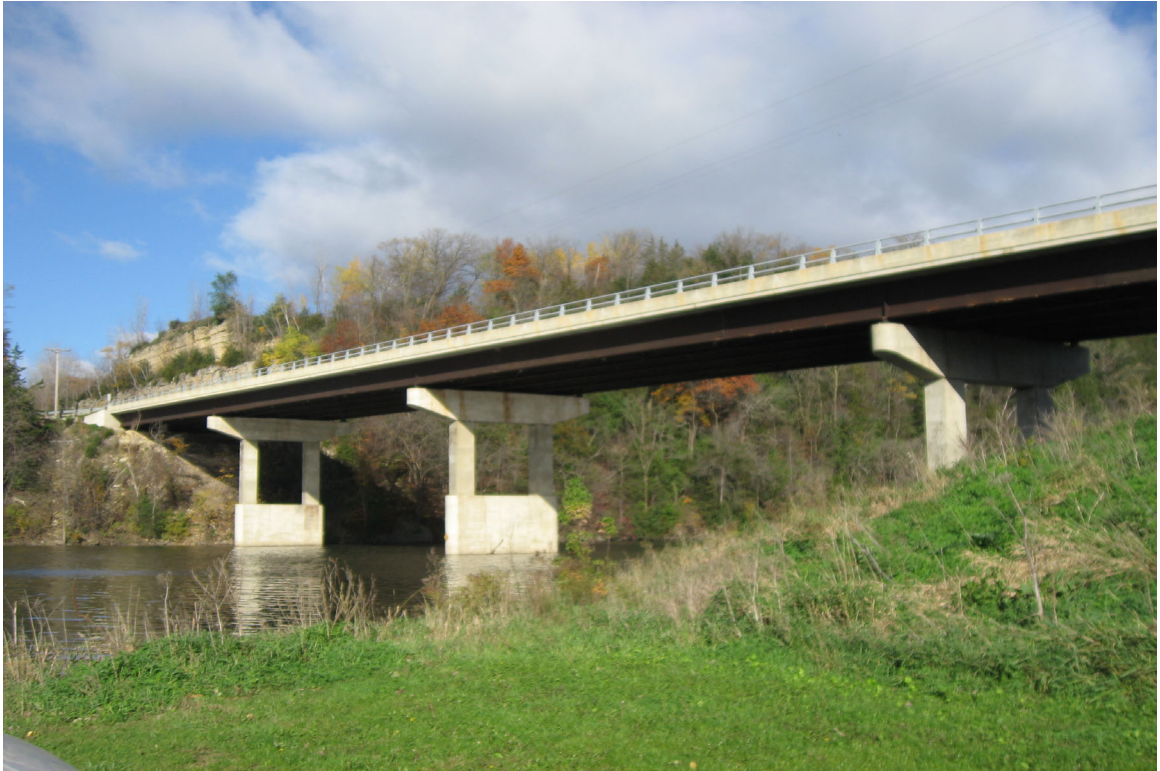
Photograph 1. Overall View of the Structure, Looking North.

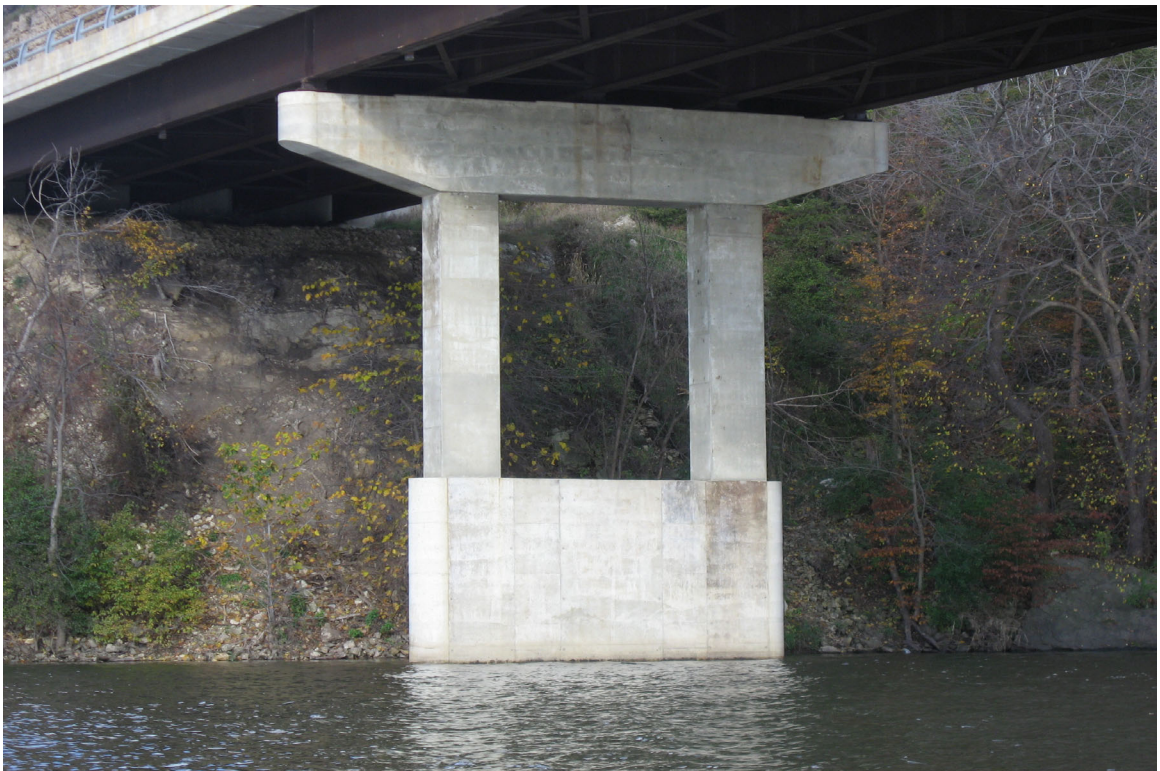
Photograph 2. View of Pier 1, Looking North.

- Footing exposure at Pier 1 was observed all around the pier with a maximum vertical exposure of 1 foot along the downstream end and east side of the pier. The surface of the footing was rough with 1 inch irregularities. At the location where the shaft meets the column, voided areas with penetrations of 1 to 2 inches and 2 to 3 inches high were observed. There was a 3 to 4 feet area where the footing was not exposed due to infilling at the west face.

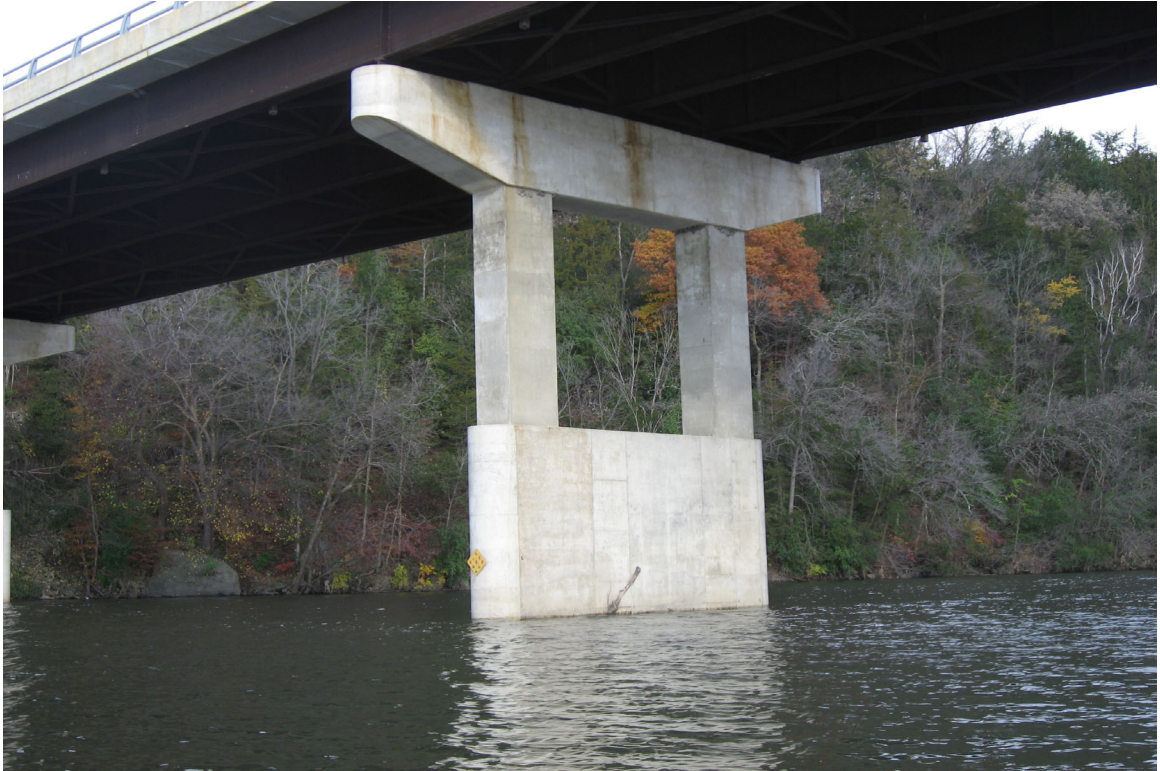
Photograph 3. View of Pier 2, Looking North.

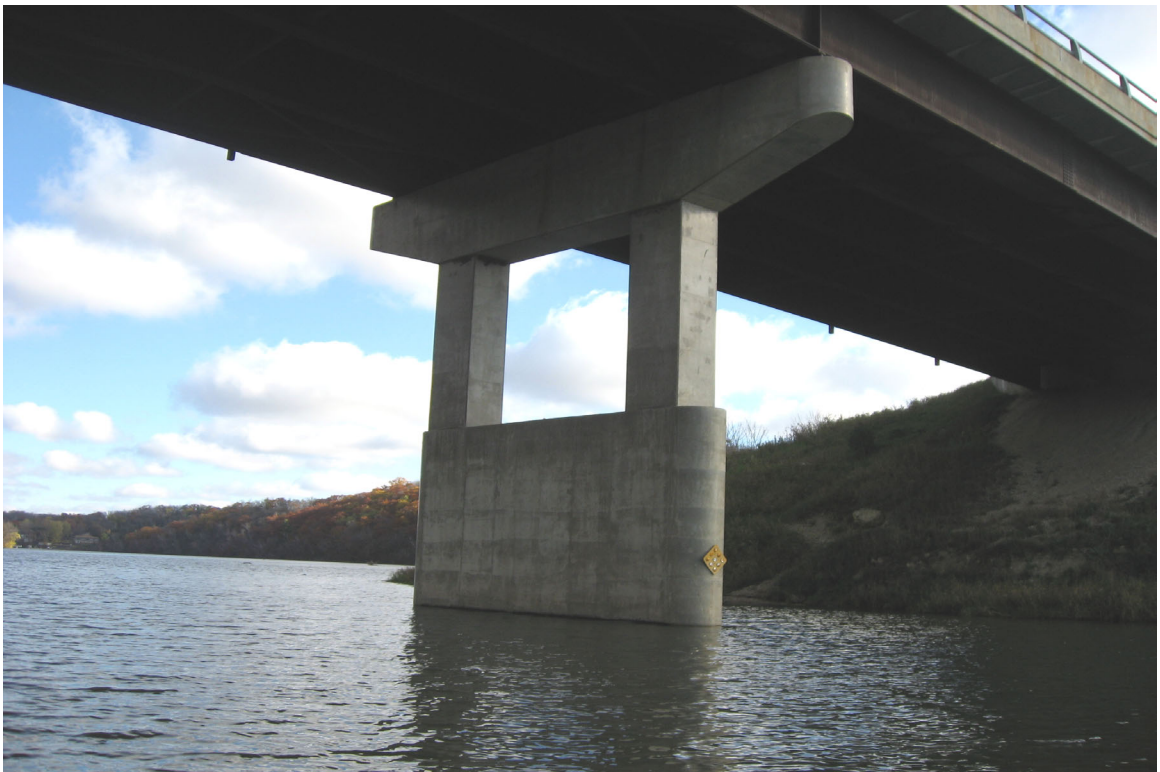
Photograph 4. View of Pier 3, Looking East.

- A scour depression 3 feet radius and 1 foot deep was observed at the upstream end of Pier 3.

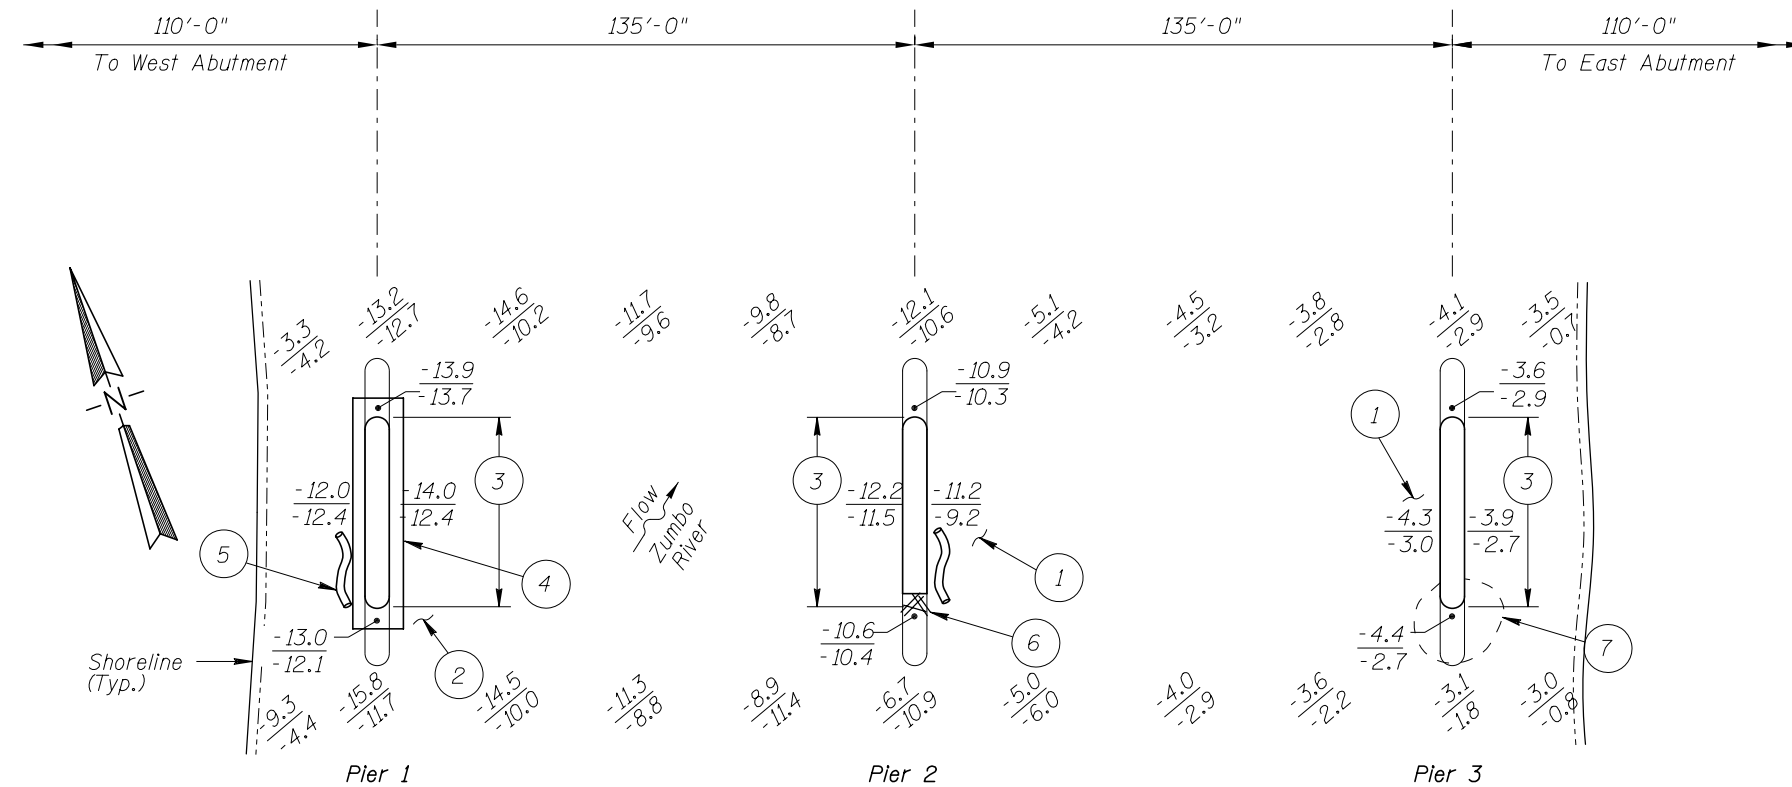
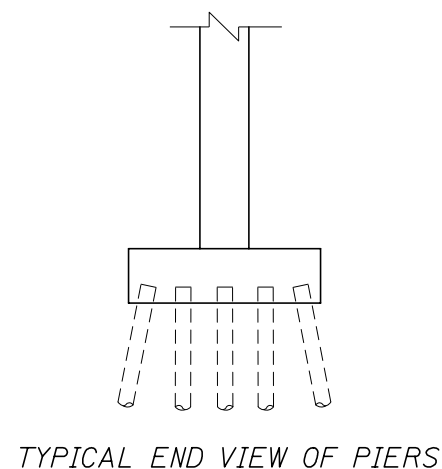
INSPECTION AND SOUNDING PLAN

- The channel bottom consisted of fine silty organics with greater than 2 feet of probe rod penetration.
- The channel bottom consisted of firm material with no appreciable probe rod penetration around Pier 1.

- Minor voids due to poor consolidation of the concrete were observed at various locations along piers, typically up to 1 inch in diameter with up to 1/2 inch of penetration.

- A tree trunk 1 foot diameter was observed along the shore side of Pier 1 on top of the footing extending from the upstream nose to shaft midpoint.
- The upstream nose of Pier 2 stops at 7 feet below water and cuts back 1.5 feet. Debris has accumulated in this area from channel bottom up 4 feet, consisting of logs and branches 1.5 feet diameter and smaller. A tree trunk was observed from channel bottom to 2 feet above water along the east face of pier.
